TECHNICAL REPORT REMR-CO-6

STABILITY OF DOLOS OVERLAYS FOR  
REHABILITATION OF TRIBAR-ARMORED  
RUBBLE-MOUND BREAKWATER AND JETTY  
TRUNKS SUBJECTED TO BREAKING WAVES

Coastal Engineering Research Center

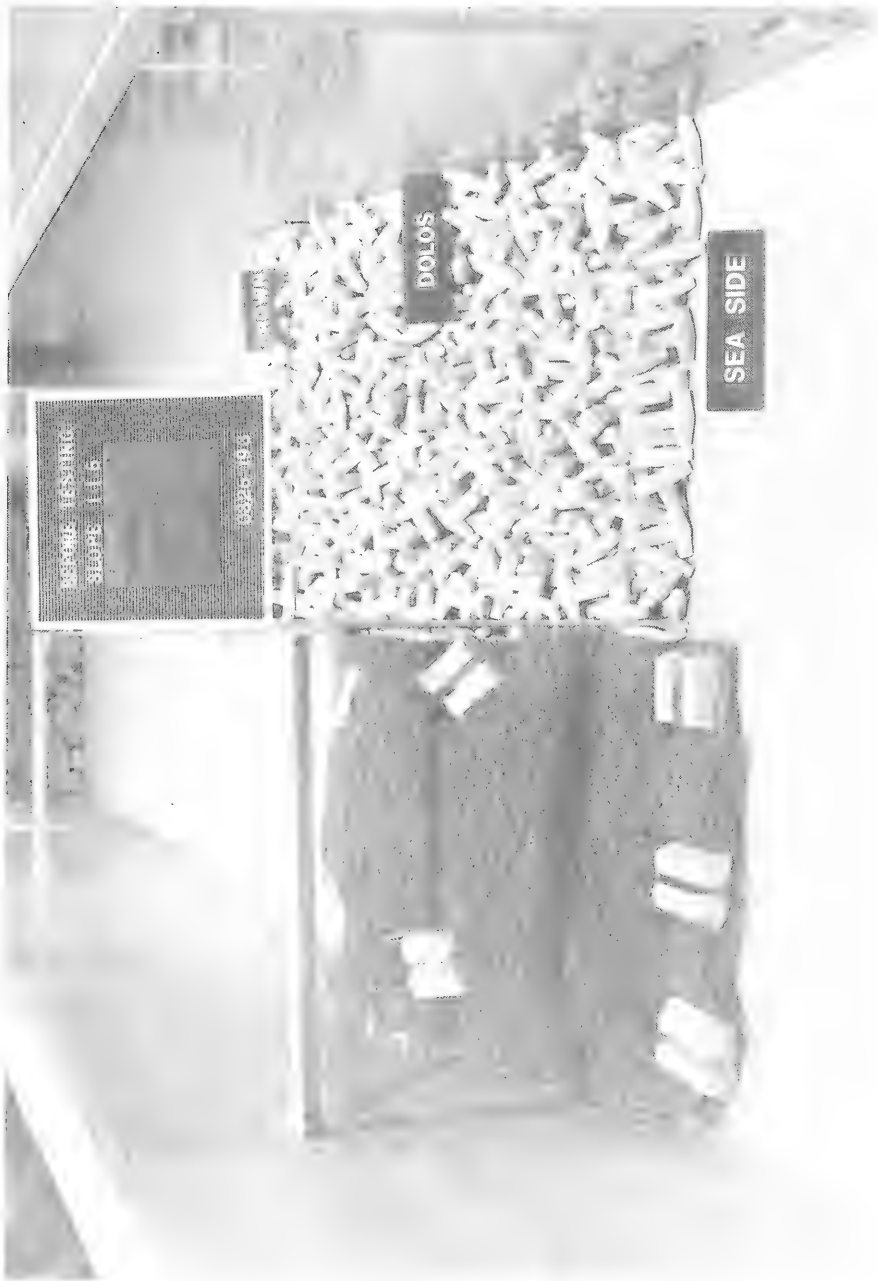
Photo 2. Sea-side view of a typical test section before wave attack at a IV-on-1.5H sea-side structure slope;  $W_a = 0.442 \text{ lb}$

17. All stability tests were conducted on sections of the type shown in Figure 1 and Photos 1-4. Sea-side slopes of 1V on 1.5H and 1V on 2H were investigated, while the beach-side slope was held constant at 1V on 1.5H. Heights of the simulated existing structures (prior to placement of the dolos overlays) varied from 1.0 to 1.2 ft. The height necessary to prevent wave overtopping of the existing structure was determined from the slopes, water depths, and wave heights investigated in determining stability coefficients for the dissimilar armor overlays.

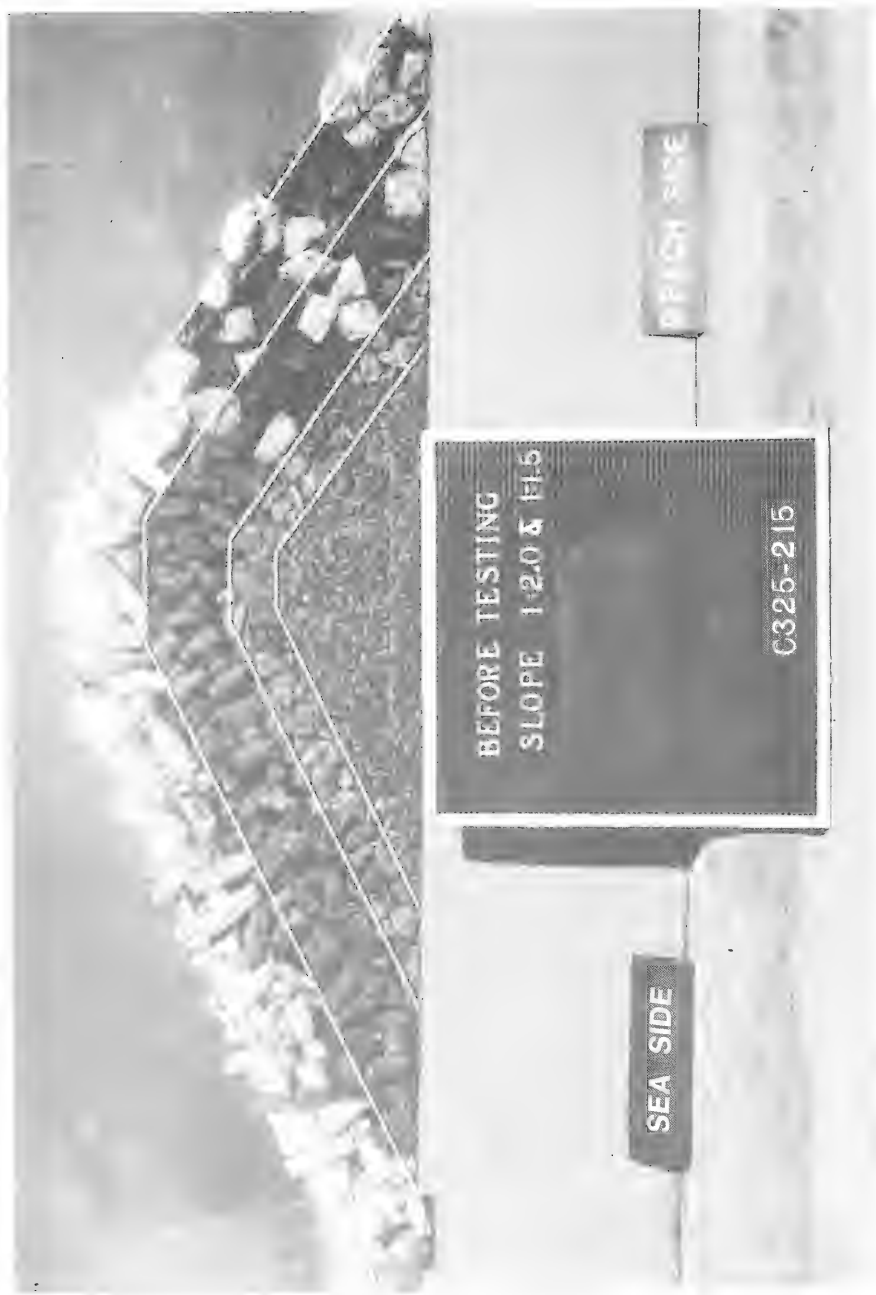
Photo 3. End view of a typical test section before wave attack at a 1V-on-2H sea-side structure slope;  $W_a = 0.589$  lb

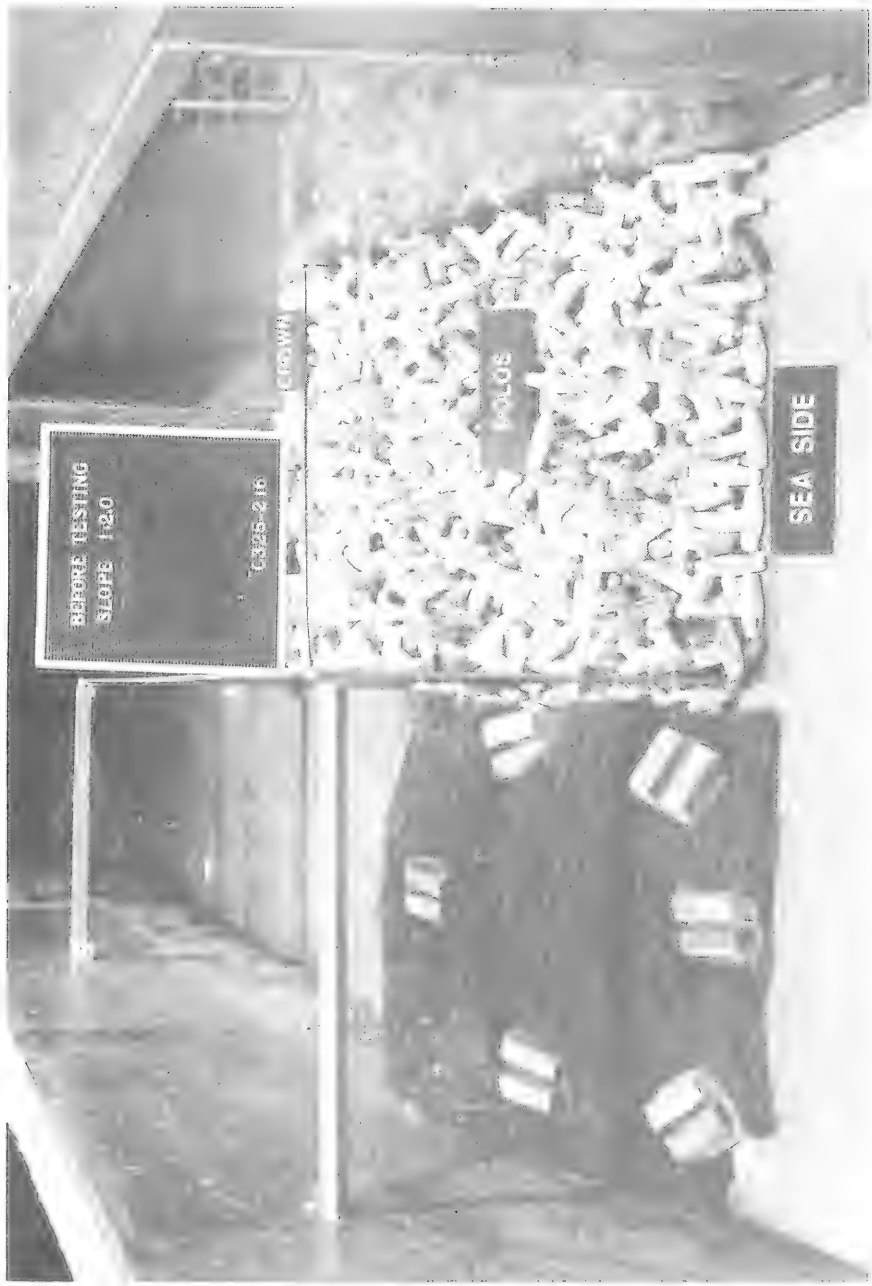
Photo 4. Sea-side view of a typical test section before wave attack at a IV-on-2H sea-side structure slope;  $W_a = 0.589 \text{ lb}$

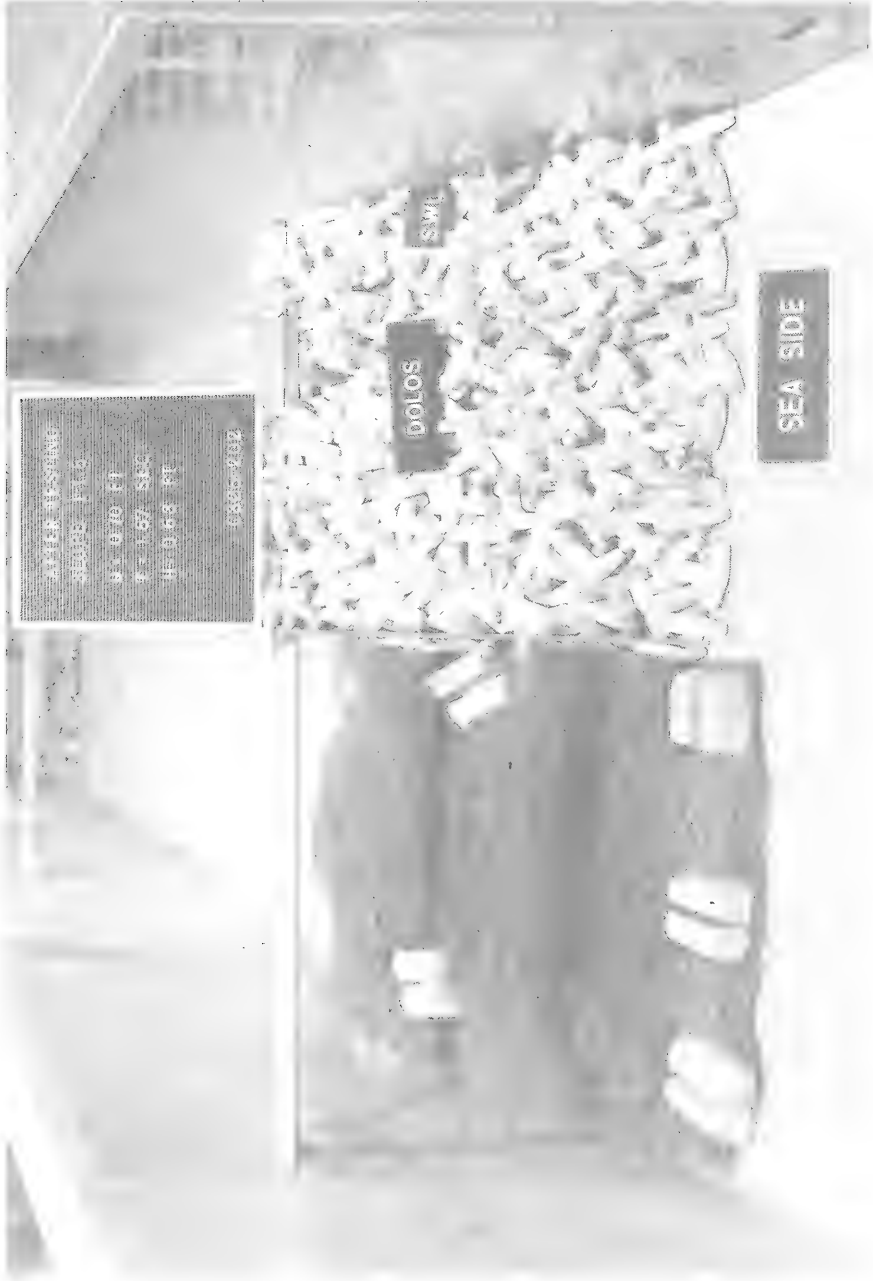
Photo 6. Sea-side view after attack of 1.57-sec, 0.63-ft waves;  $d = 0.70$  ft;  
 $W_a = 0.589$  lb; 1V-on-1.5H structure slope

Armor units were placed randomly in two layers, and the number of armor units per given surface area was equal to that presently recommended for new construction in EM 1110-2-2904 (Headquarters, Department of the Army 1986). Photos 5-11 show typical after-testing conditions of the structures.

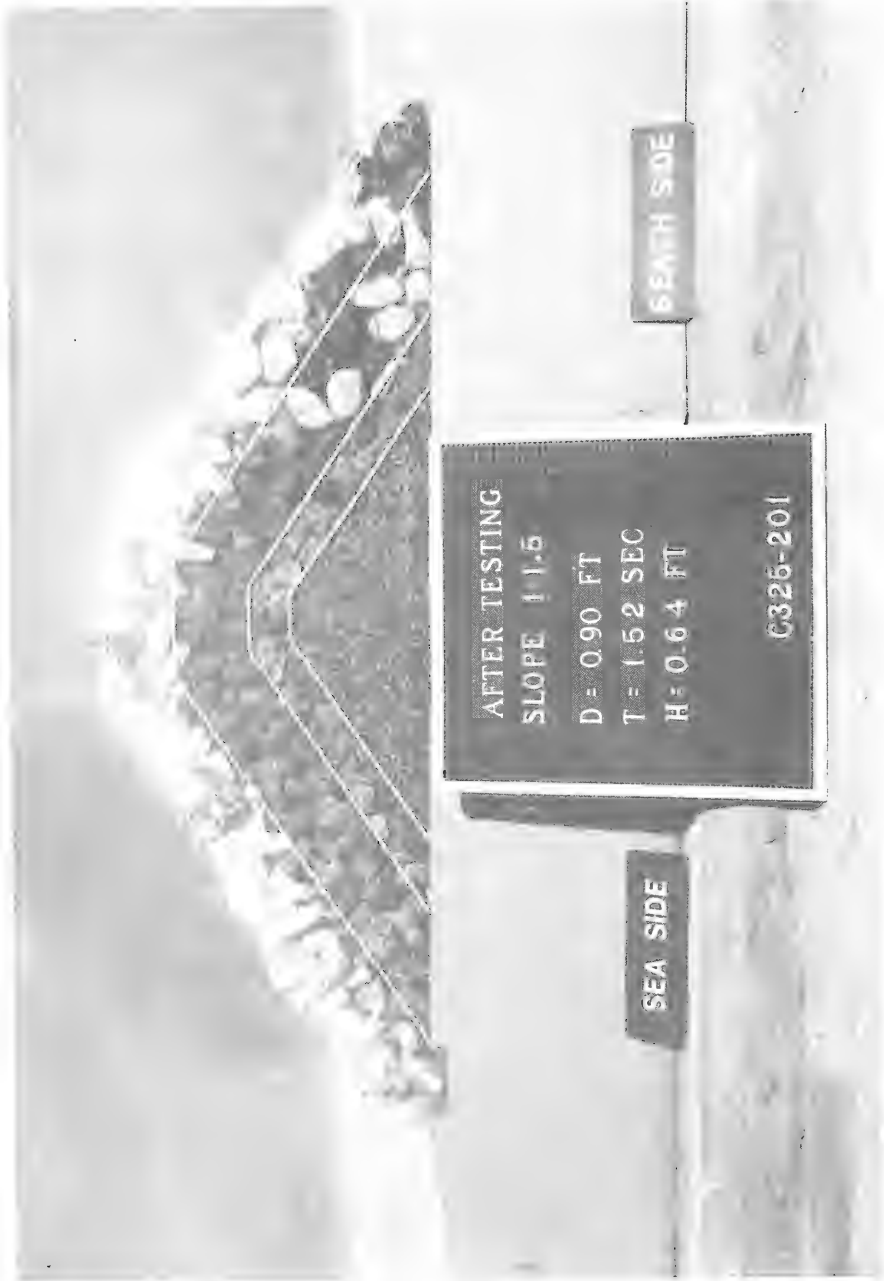
Photo 7. End view after attack of 1.52-sec, 0.64-ft waves;  $d = 0.90$  ft;  
 $W_a = 0.589$  lb; IV-on-1.5H structure slope

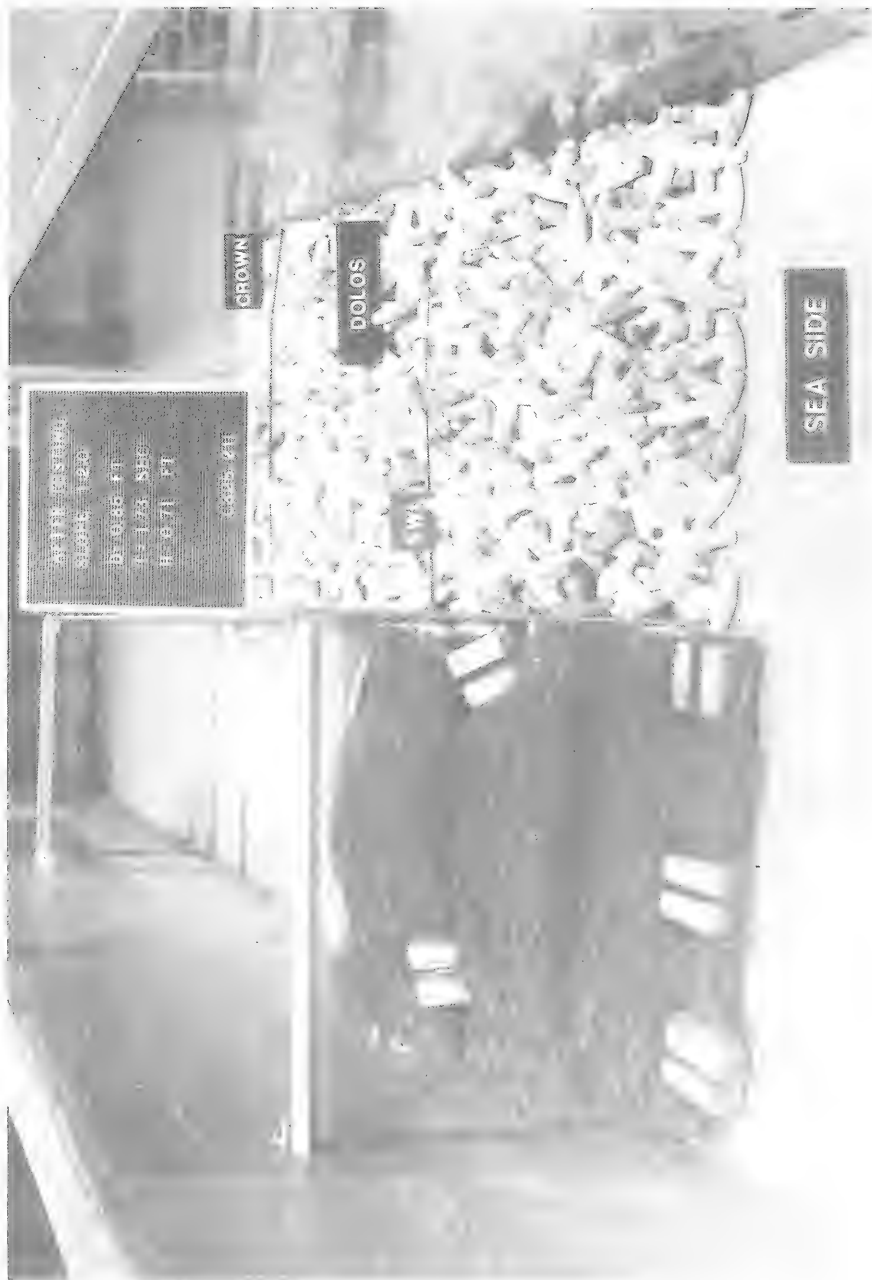
Photo 10. Sea-side view after attack of 1.73-sec, 0.71-ft waves;  $d = 0.85$  ft;  
 $W_a = 0.589$  lb; IV-on-2H structure slope

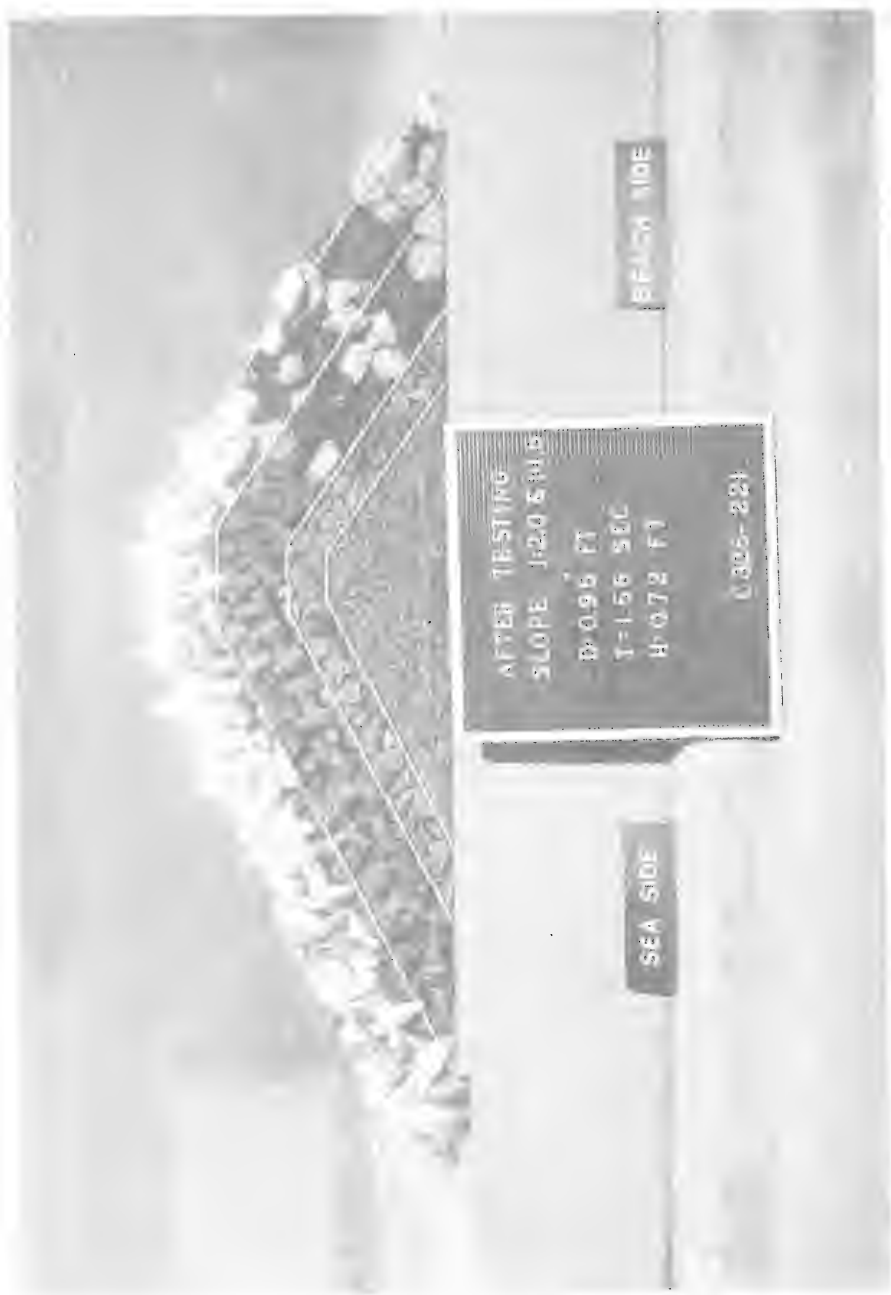
Photo 11. End view after attack of 1.56-sec, 0.72-ft waves;  $d = 0.95$  ft;  
 $W_a = 0.589$  lb; IV-on-2H structure slope
